Manhole Inspection Summary

Manhole # S29M1_008MH

Insp Date: **4/12/09 12:53 PM**

Location Address: **Spelman Rd.**

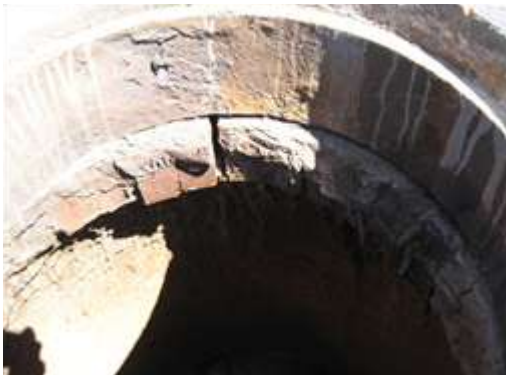
Defect 2

Condition: ☐ Sound ☒ **Cracked** ☐ Root Intrusion ☐ Loose Brick ☐ Deteriorated

Infiltration: ☐ None ☐ Joint ☐ Cracks ☐ Mortar ☐ Roots ☒ **Wall**

cracked chimney

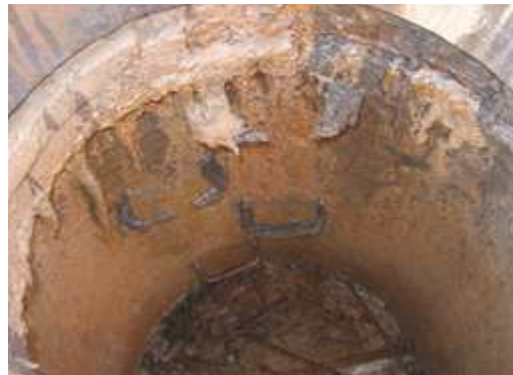
Defect 3

Count: **3** Missing: **2** ☒ **Corroded**

missing steps

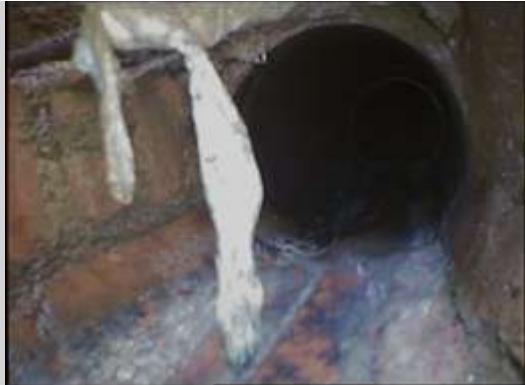
12 O'Clock Outflow

10 in. Circular Gravity Sewer
Pipe Out @ 12 O'Clock

Pipe Height: **9.6** (in.) Rod and Bar (Angled)
Pipe Material: **Clay** ☐ Pipe Lined
Invert Depth: **7.80** (ft.) Flow Characteristics: **Slow**
Deposits: ☒ None ☐ Mud ☐ Sludge ☐ Debris ☐ Grease
Silt Depth: (in.) Deposits Extent:
Infiltration: **None** Pipe Seal Cond: **Sound**

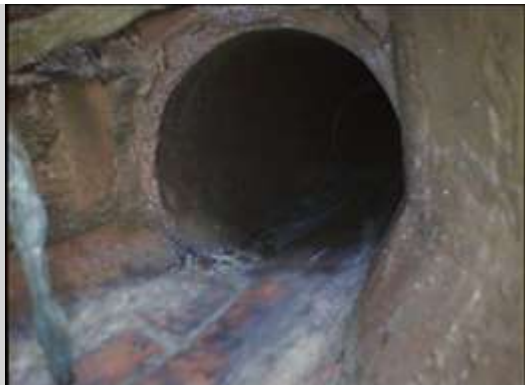
3 O'Clock Inflow

8 in. Circular Gravity Sewer
Pipe In @ 3 O'Clock

Pipe Height: **8.4** (in.) Rod and Bar (Angled)
Pipe Material: **Clay** ☐ Pipe Lined
Invert Depth: **7.80** (ft.) Flow Characteristics: **Slow**
Deposits: ☒ None ☐ Mud ☐ Sludge ☐ Debris ☐ Grease
Silt Depth: (in.) Deposits Extent:
Infiltration: **None** Pipe Seal Cond: **Sound**

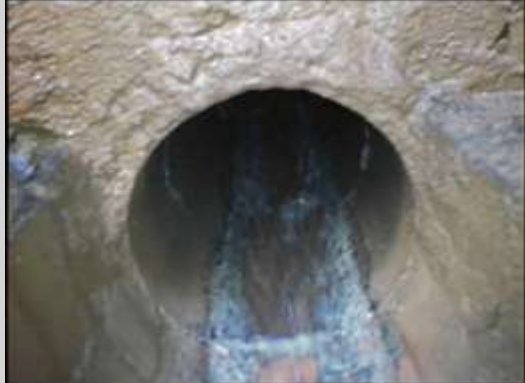
6 O'Clock Inflow

10 in. Circular Gravity Sewer
Pipe In @ 6 O'Clock

Infiltration: **None** Pipe Seal Cond: **Sound**
